**WARD BRANCH STREAM RESTORATION
PROJECT**

POST-CONSTRUCTION ASSESSMENT

FINAL REPORT

August 27, 2008

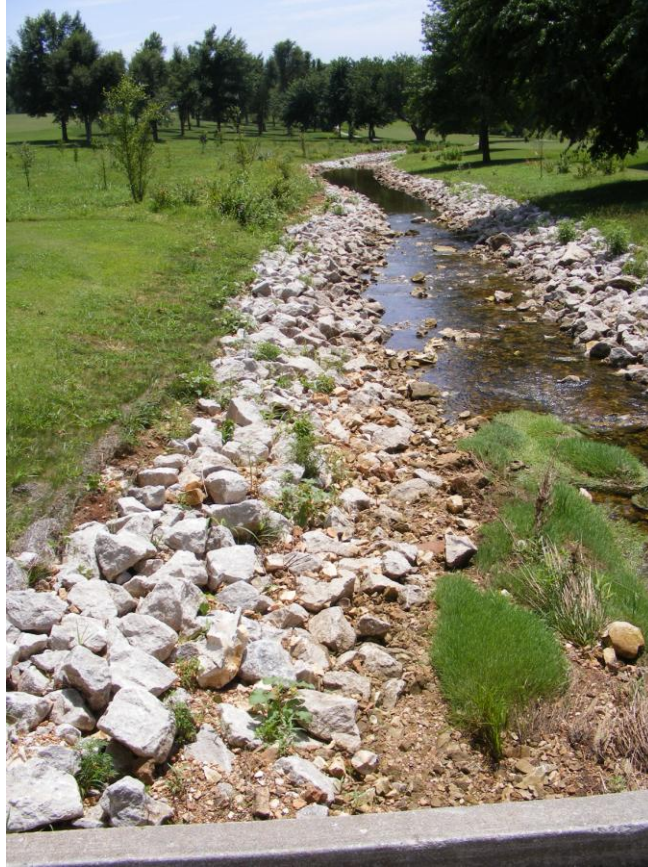
1. Erosion is occurring behind the toe protection along the east bank of the stream between stations 200 and 300 feet on the inside of a bend in the channel (Picture 21).

Picture 21. Looking downstream of first cart bridge July 2008. (St. 120 ft)

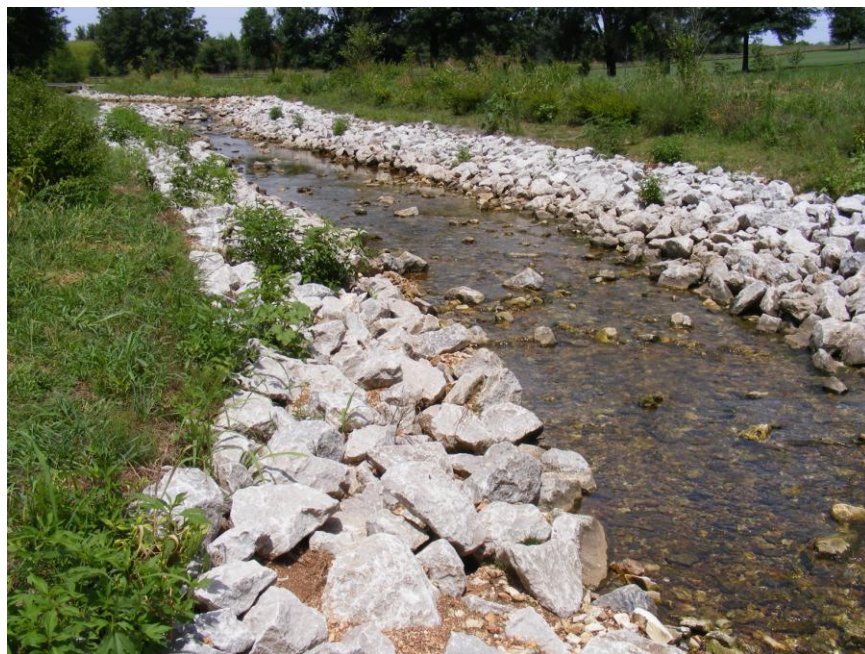
Picture 22. Step-pool reach below first grade control structure, July 2008 (St. 500 ft)
